POPPLETON HISTORIC STUDY

B-2621

1122-1140 Hollins Street (1122-1136 demolished)

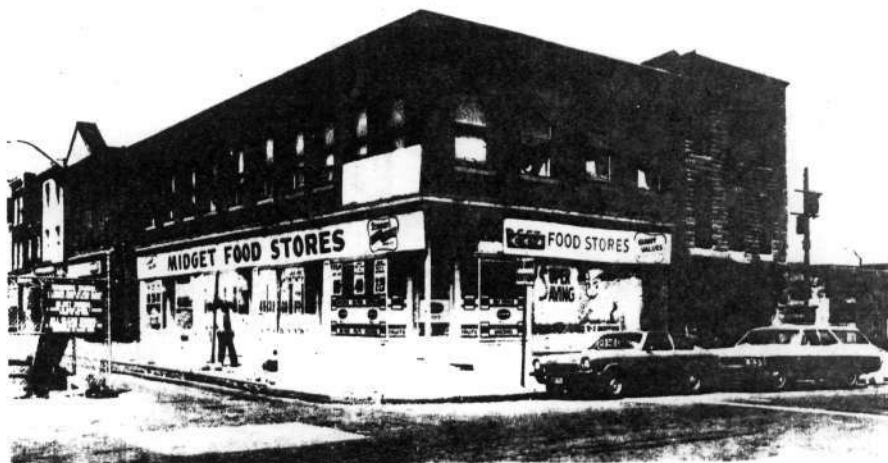
B-2621

The destruction of these buildings 1122-1134 did more harm than good. The gap they left is unsightly. The record seems to indicate that some old houses were among the losses. Number 1138/1140 is quite a nice early 20th century building; it should stay. Note the swag motif of the architrave. It is also important store in this area. Number 1136 has been badly burned but if it can be saved it should remain.

Lots (41-35 and 82-83) at 1122-1134 (and 28-30 S. Carlton) have been cleared and 1136 is vacant. Proposed parking lot will not give definition and edge to the Market that the houses did. Market is across-street and plan for Market must strongly influence the use of these lots. The least that should be allowed if for parking is an enclosing wall and heavy planting of trees and shrubs at front (Hollins) and rear (alley side).

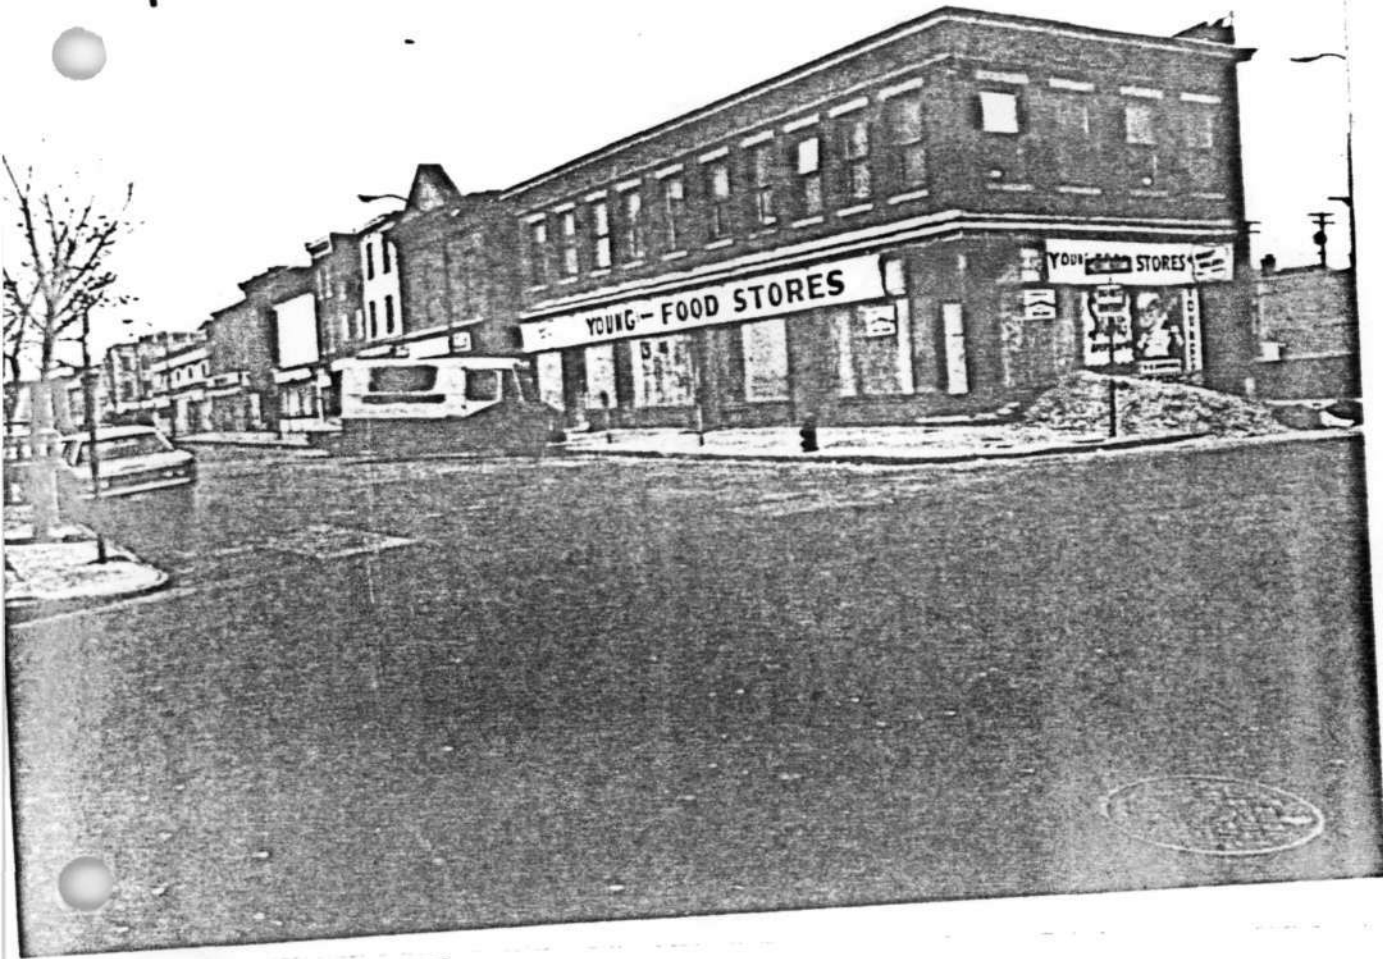
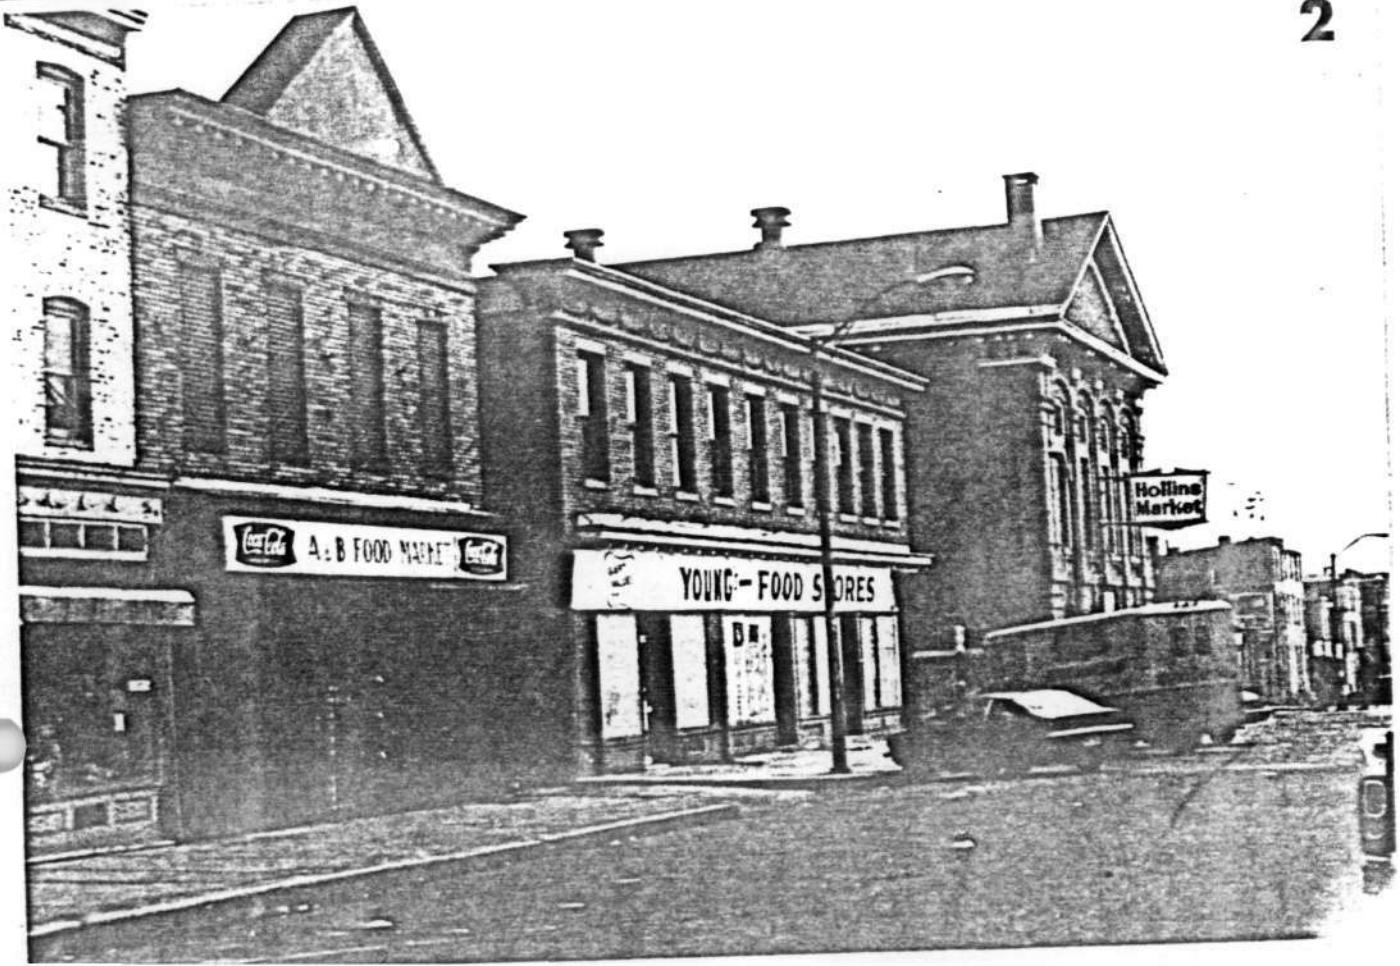
The building is a freestanding, rectangular shape, 67' long by 31' wide, with a ground floor below grade, first and second story a height of approximately 24'. The building is wood frame with exterior brick bearing walls. The brick is tan and hardbaked, with a smooth finish.

Two sides of the building have a parapet entablature with a metal architrave, and ornamental metal freize topped with a metal cornice, all of which are a soft grey color.

These two walls (one facing west, 67' in length, and the other facing south and 31' in width) have windows on the first and second stories. The first story of the west wall has a bank of 4 large storefront windows which are boarded over at present, but are to be restored with laminated glass to recreate their original appearance. The second story of the west wall has a bank of 10 large double hung windows, each window having a limestone lintel and sill. Above the first floor windows is a cornice which is architecturally compatible with that at the roof line. A streamer of lights above a large wooden sign, running the length of the wall was added to the wall relatively recently. The lights and sign will be removed in order to restore the building to its original appearance.

The south wall contains a similar configuration of windows, having a single large storefront window on the first story and 4 large double hung windows on the second story.

The intersection of these two walls contains a recessed entrance with a triangular concrete entry slab. A slight regrading of the sidewalk around this slab will allow for access for the handicapped with no basic change in the exterior appearance of the building. There are two additional entrances along these walls, one an entry to the second story located at the southeast corner of the second wall, and an entrance to the first story area at the northwest corner of the first wall.

The north and east walls of the building are blank, having at one time been attached to adjacent structures. They are both finished with a smooth, sand colored stucco.
